**NEBRASKA DEPARTMENT OF ROADS  
SUPPLEMENTAL INSPECTION PROCEDURES**

**RAVENNA VIADUCT  
RAVENNA, NEBRASKA  
PROJECT NO. BR-68-2 (102)  
STRUCTURAL NO. S068 00044  
CONTROL NO. 42141**

Prepared by the Bridge Office

January 2010

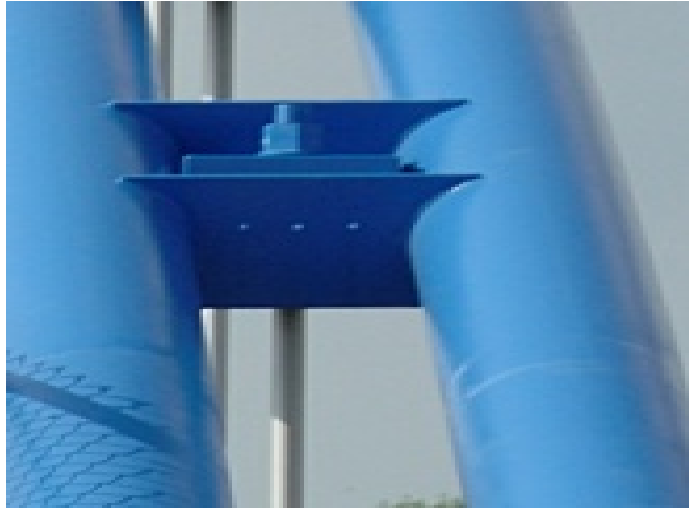
### At the top

The hanger connection between the two arch pipes is a critical welded connection.

Inspectors should inspect all welds connecting the hanger to the pipe. Inspectors shall insure the weep holes in the hanger plates are clear of debris that would inhibit proper drainage on the hanger plates.

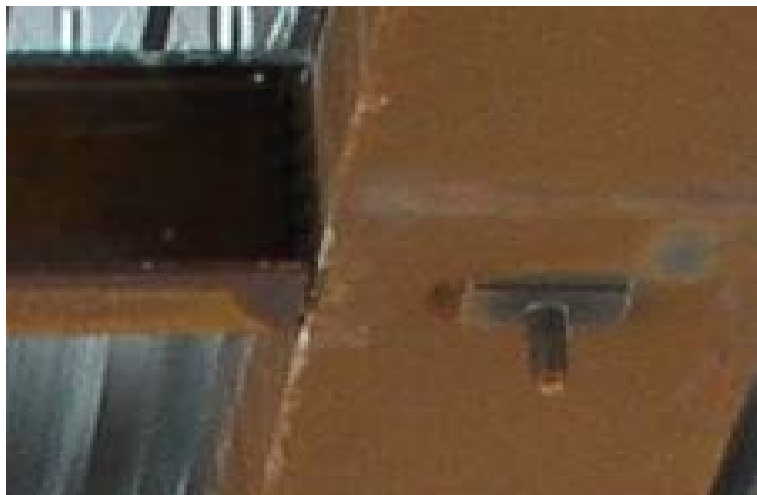
### At the Bottom of Box

The above photo shows the Threaded Nuts at the bottom of the hanger rods. Nuts at the top and bottom of the hanger rods shall be inspected for cracks as well as tightness.

The welds on the beveled plates located as shown in the above photo where the threaded rod is attached to the bottom of the box should also be inspected.

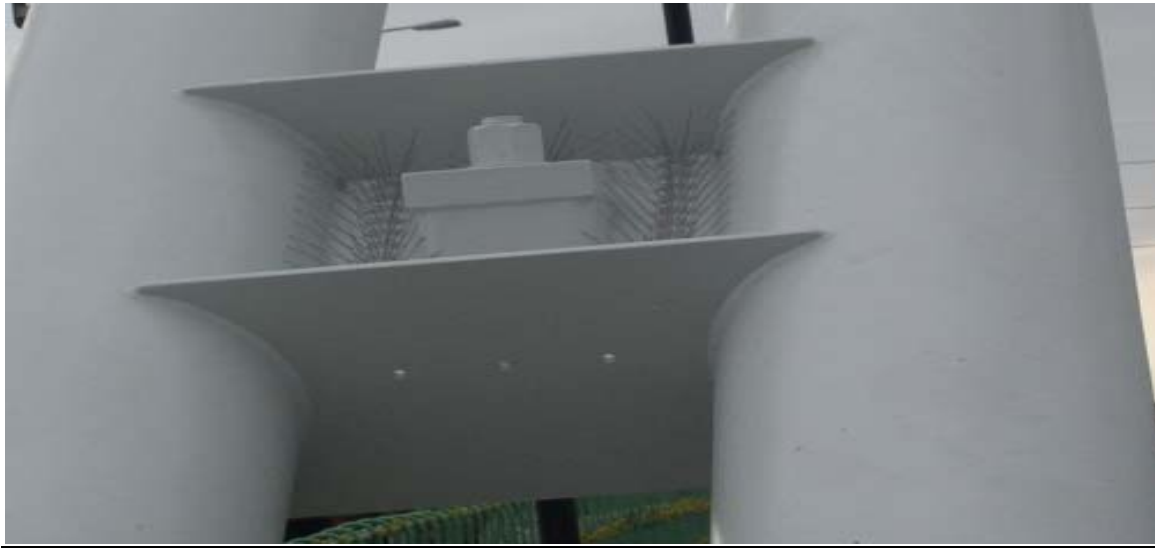
Below is a picture of the wire spikes used on the Columbus Viaduct.

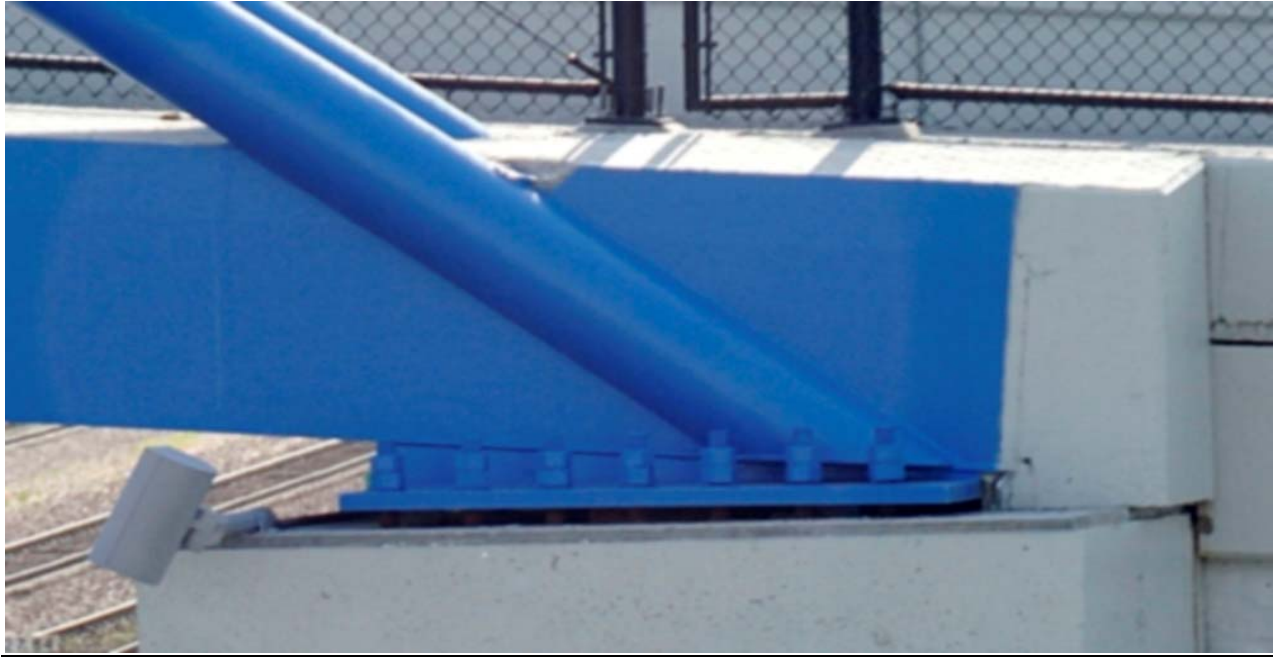
Inspecting the Expansion Devices:

All visible welds at the Arch to Tie-Beam and Tie-Beam to Sole Plate connections shall be inspected for cracks.

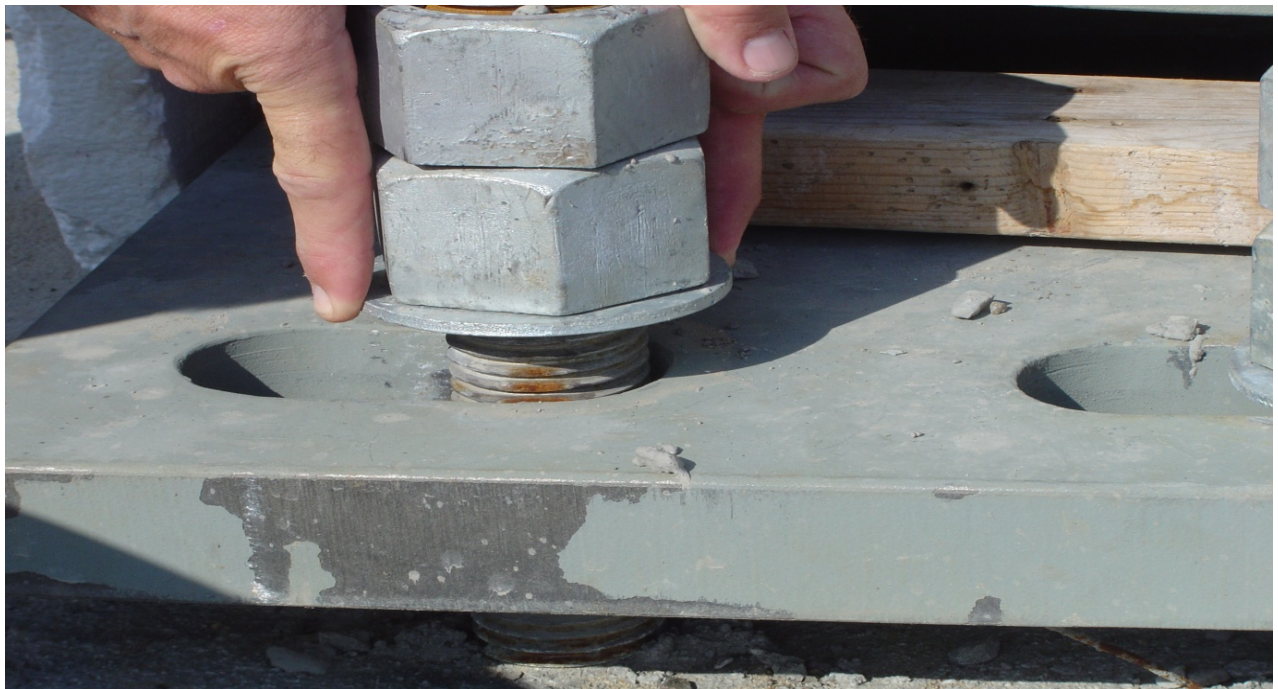
Also slots in the Expansion devices should be checked for cracks and the clearance between the bolts and the slots should also be checked for the proper allowed movement.
